## How to rectify the unknown VSWR alarm of NHR-1500

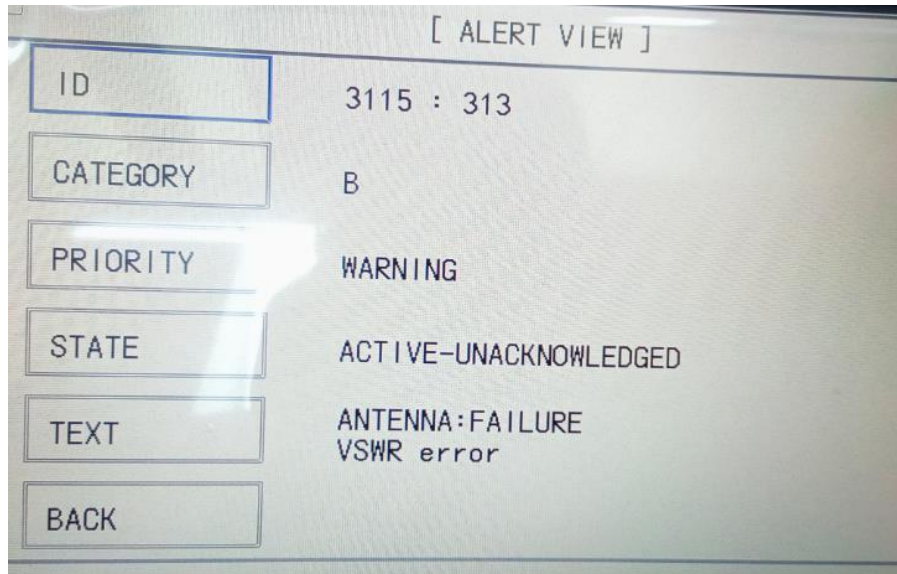
Problem: unknown VSWR alarm after transmitting.

1. Upgrade the firmware of control unit to version of V1.18 20230418 or newer.  
If possible, the firmware of transceiver unit can be upgraded to V1.13 20230406 or newer.  
With new firmware, the transmitter will be automatically tuned before transmitting. If tuning OK, high VSWR will not happen easily.

2. Check the antenna coupler, it should tune OK on each band. "READY" signal should be sent from the antenna coupler to the transceiver unit.  
The antenna coupler will make "Ta..Ta..Ta.." sound when tuning at new frequency never used.  
If tuning fails at one or some bands, the antenna coupler or RF cable & antenna may have some problems.

3. Check the RF cable with connectors and the antenna.  
Usually the problem comes from them.  
The RF cable should be at least RG213.  
Sometimes even enough the connector is measured well, it can't stand high RF power and results in high VSWR.
