SERVICE MANUAL

MF/HF RADIO (GMDSS)

NHR-1500

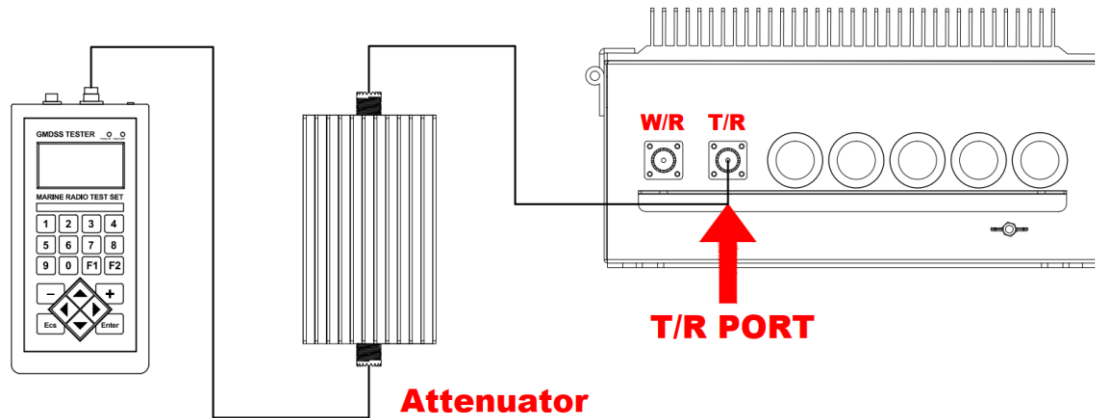
- 1) Connect the GMDSS tester to the TR port with a 200W 40db attenuator.

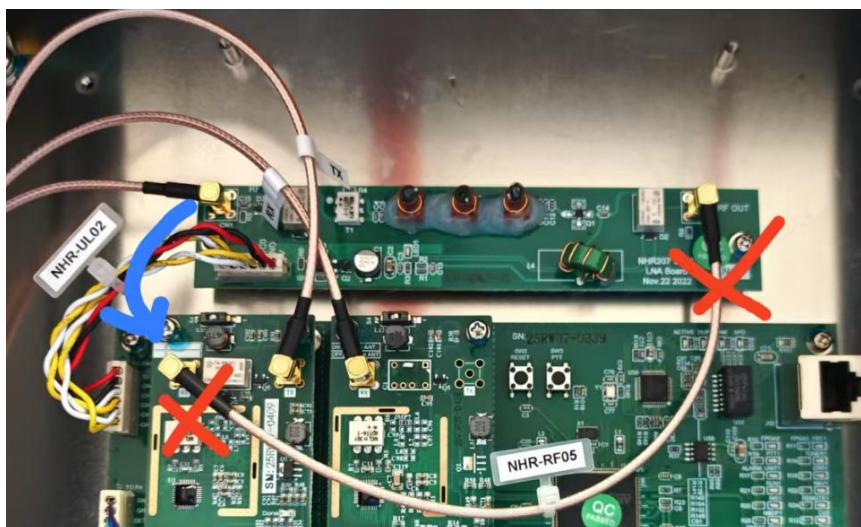
4) If Step 3 is not OK, bypass the LNA board, then repeat the test of Step 2.

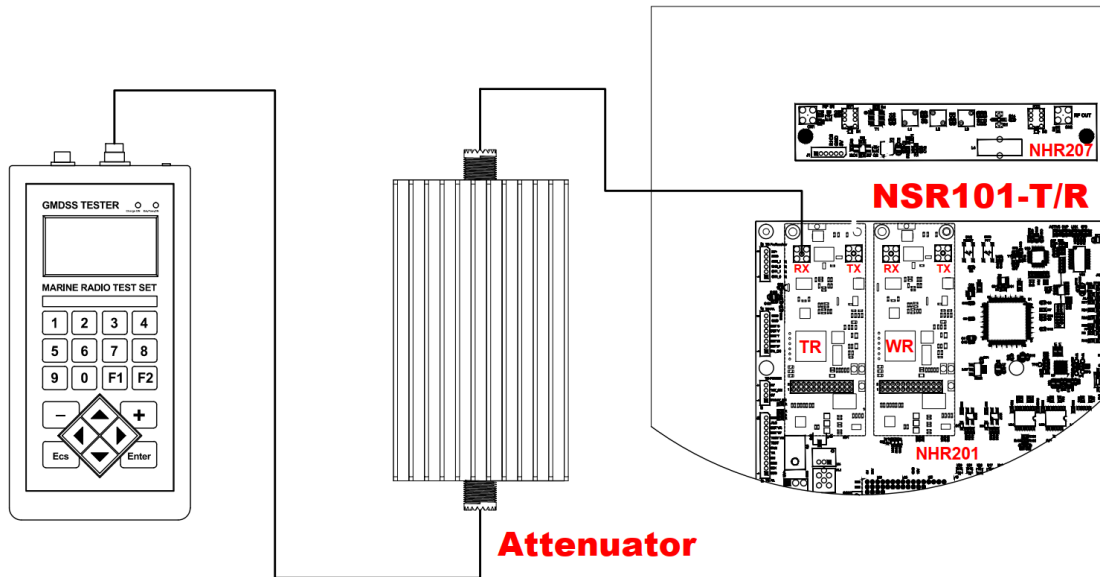
- 5) If Step 4 is not OK, connect the GMDSS tester to NSR101 TR board with a 200W 40db attenuator. Then repeat the test of Step 2.

If Step 5 is OK, the internal RF cable or NHR206 filter board should be faulty.
If Step 5 is not OK, the NSR101 TR board should be faulty.

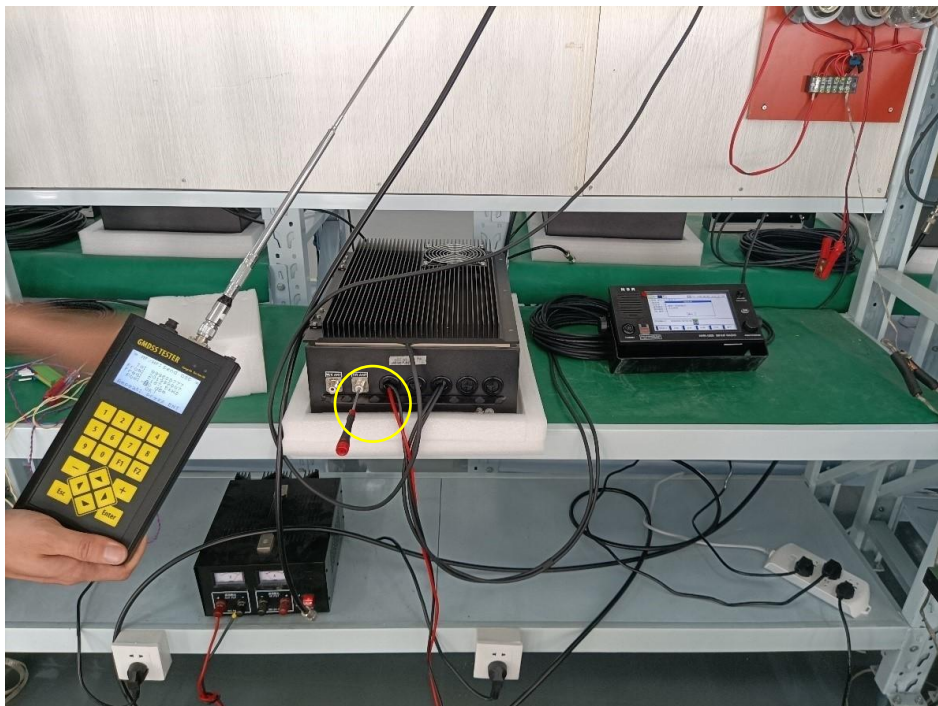
Insert a screwdriver into the TR ANT port as an antenna to receive the transmission from the GMDSS tester.

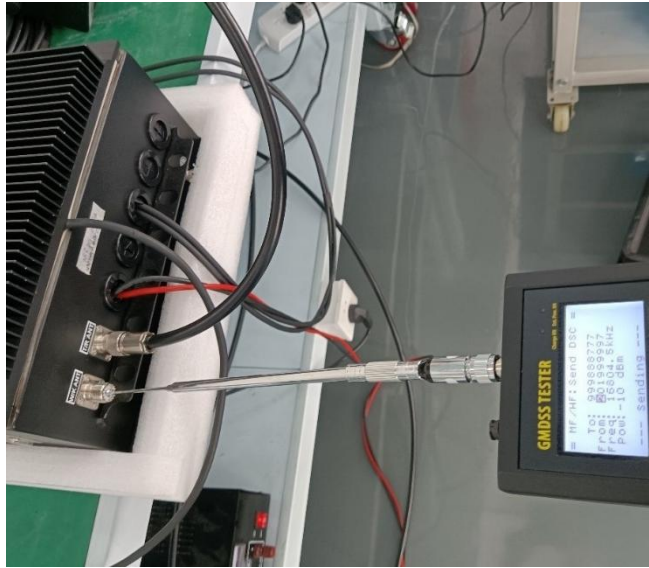
Touch the WK ANT port with the GMDSS tester's antenna.

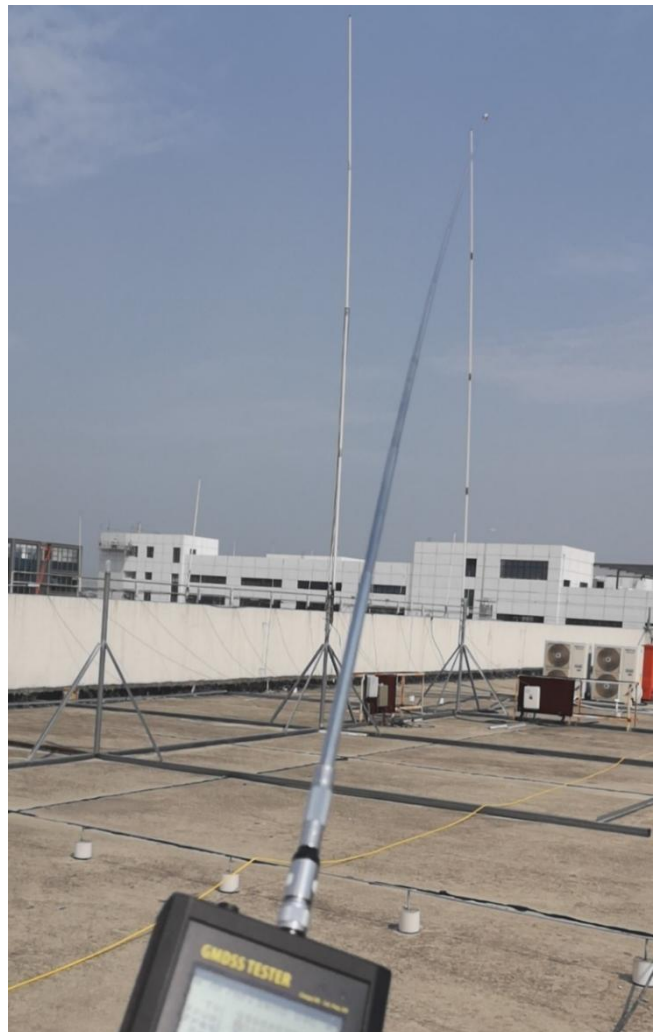
Radiate RF signals to the TR antenna.

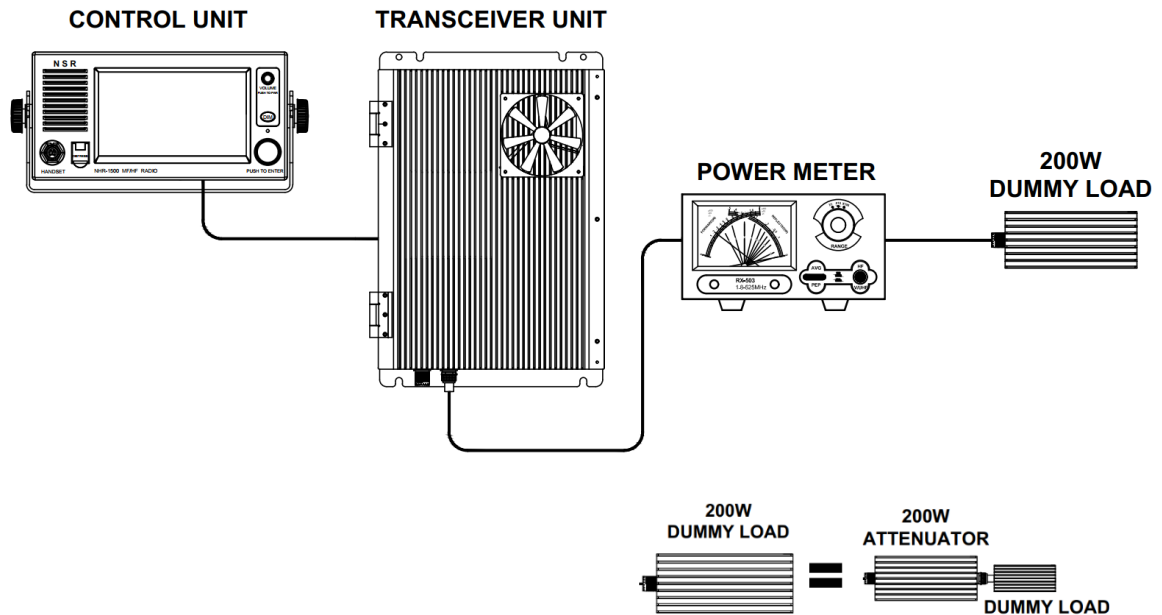
2.4.1 Connection

Note: The 200W dummy load can be replaced by a 200W/40dB attenuator and a 20W dummy load.

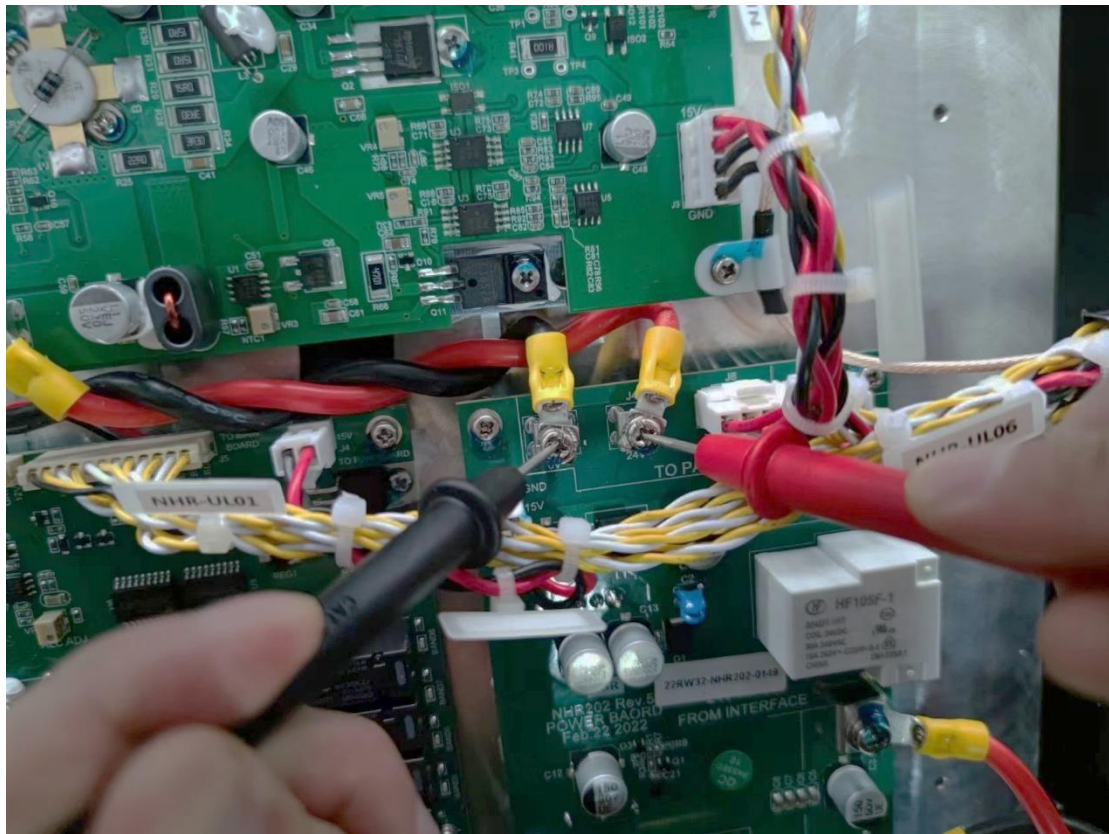
Measure the voltage at NHR202 PCB, from the connector “TO PA”.

Press “TUNE” on the control unit. The voltage to PA should be 24V DC. If no 24V at PA power supply, the ISO1 at NHR201 PCB needs replacing.

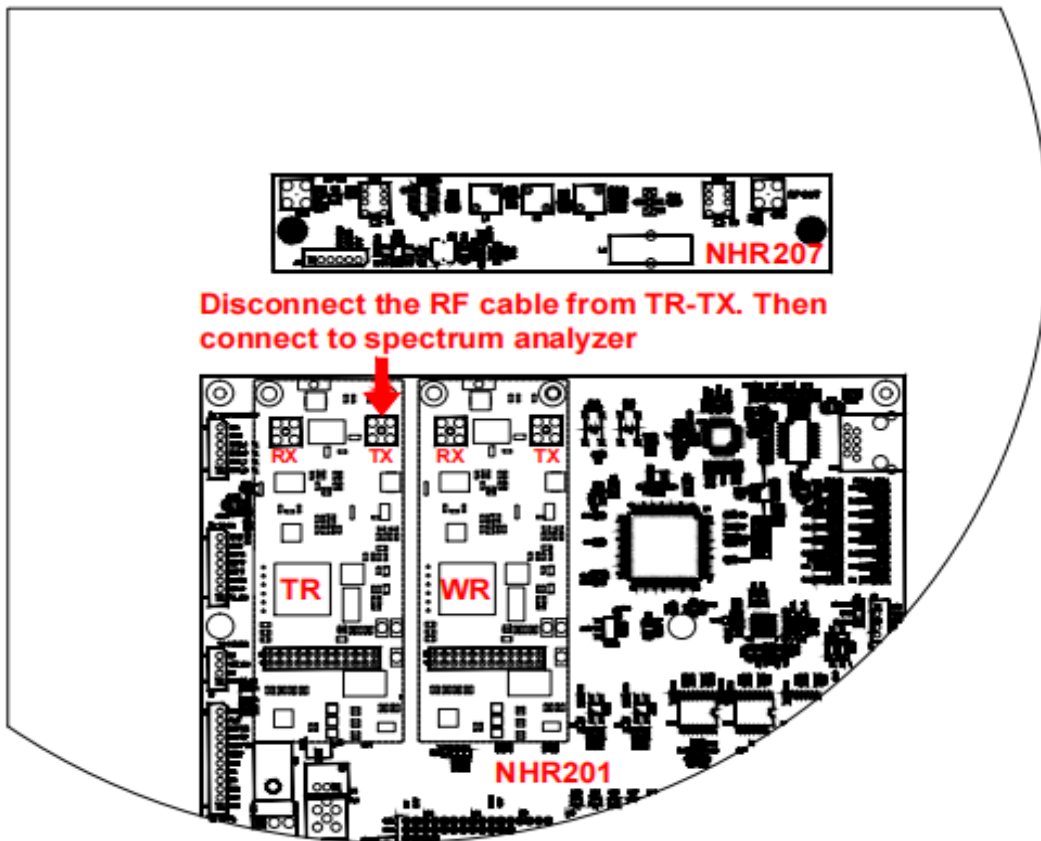
Disconnect the RF cable from the TR board - TX, then connect to the spectrum analyzer. If the spectrum analyzer is not available, an oscilloscope may be used instead.

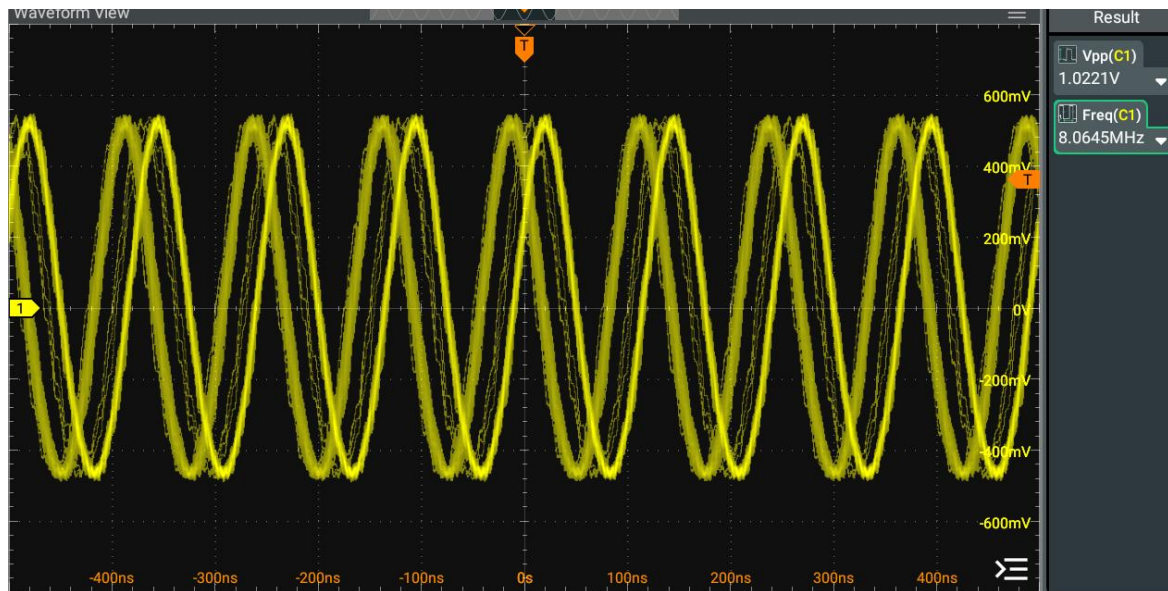
TX output at the TR board, measured at the oscilloscope. The Vpp should be around 1V, and Freq should be around 8MHz.

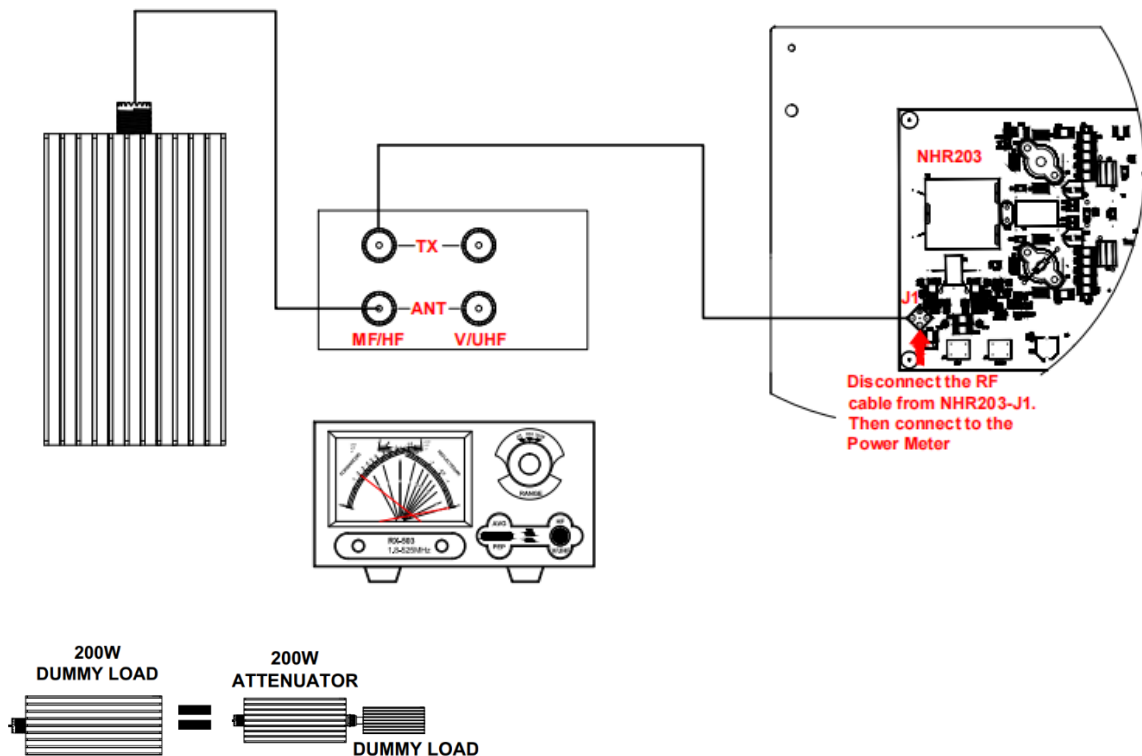
Find J1 on NHR203, and disconnect the RF cable. Then connect to the power meter and dummy load. Set the power meter as **【HF】** and choose **【PEP】**, set the range as **【x100】**.

Note: the 200W dummy load can be replaced by a 200W/40dB attenuator and a 20W dummy load.

Click [TX] on the POWER SET screen. If the NHR203 is OK, the power meter shows about 20W. If no power output, maybe NHR203 was damaged. If NHR203 is OK, disconnect the power meter and turn back to connect the RF cable. Stop [TX] on the POWER SET screen and check the next point.

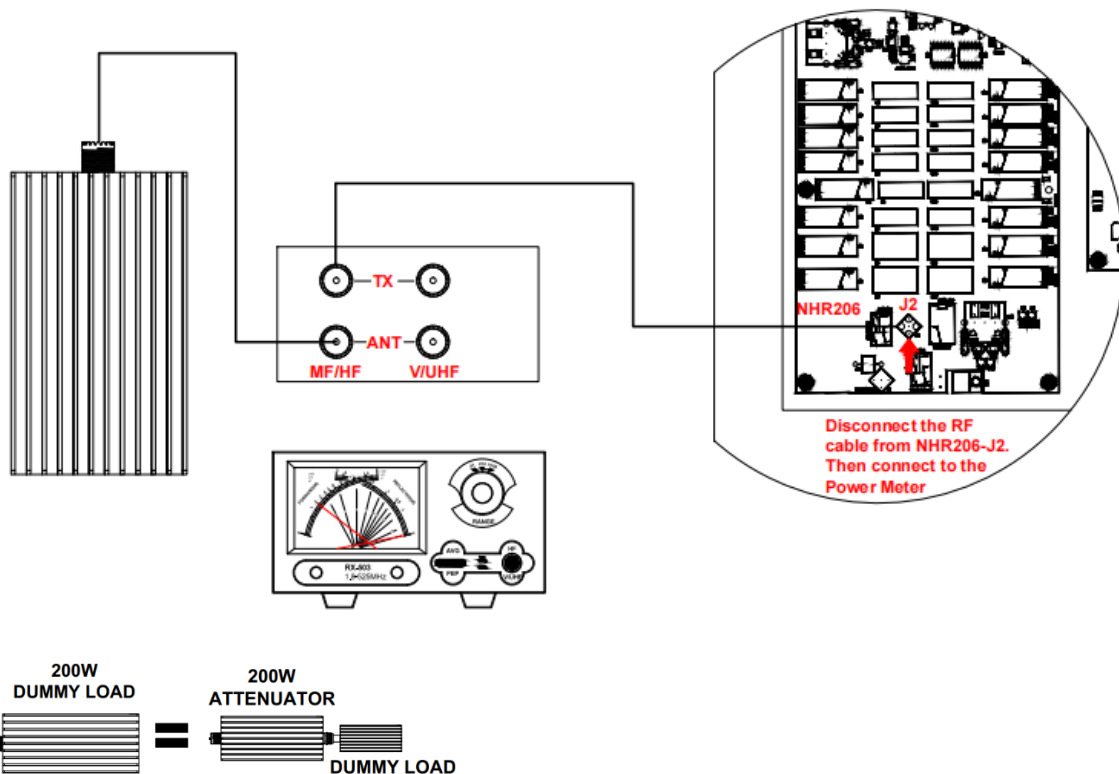
- Find J2 on NHR206 and connect it to the power meter, then click [TX] on the POWER SET screen. If the NHR206 is also OK, the power meter shows about 20W. If no power output, maybe NHR206 was damaged.

Note: The 200W dummy load can be replaced by a 200W/40dB attenuator and a 20W dummy load.

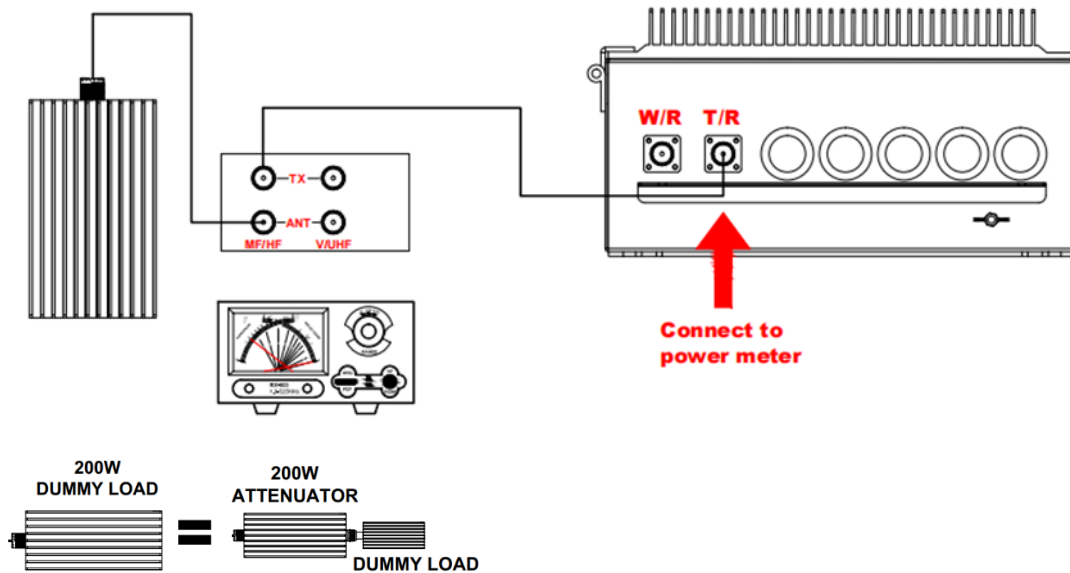
- 5) Stop [TX] on the POWER SET screen. Turn back the RF cable on J2. Connect the power meter to T/R port on the transmitter, then click [TX] on the POWER SET screen. Check the power meter, it should be 20W. If no power output, check the RF cable between the NHR206 J2 and to T/R port on the transmitter.

Note: The 200W dummy load can be replaced by a 200W/40dB attenuator and a 20W dummy load.

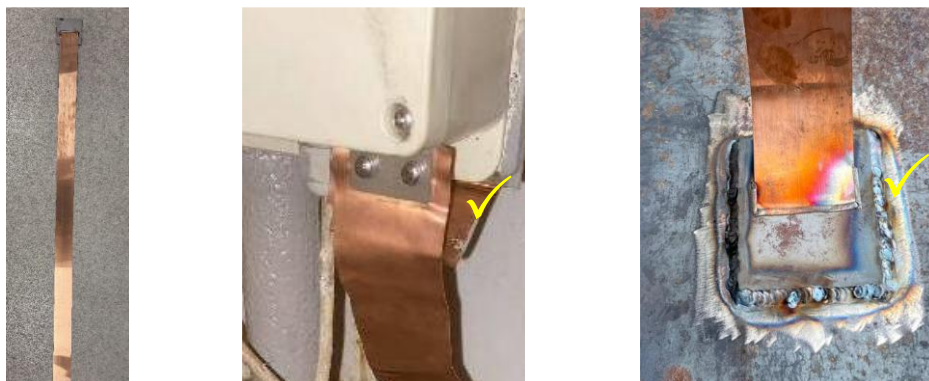
Since April 2025, an upgraded grounding strip has been supplied with ATU, which is attached with an iron plate. Please weld the plate to the hull for better grounding.

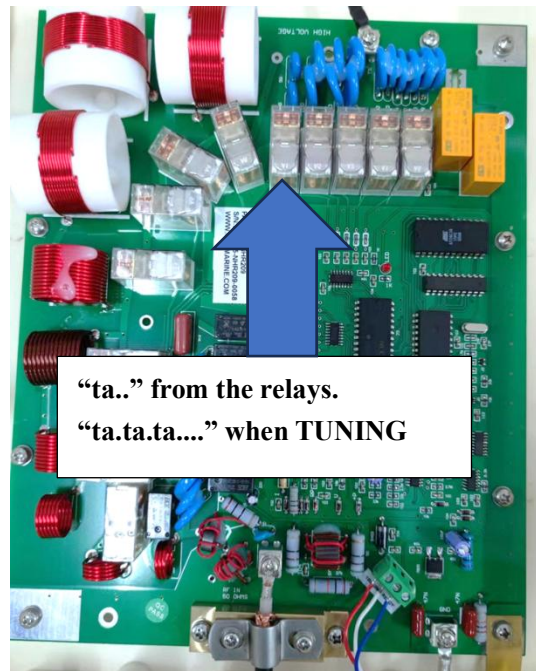
Disconnect and then connect the power cable, the relays of ATU make the short “ta..” sound.

If no “ta..” sound when ATU is powered ON, check the power supply to the coupler at NHR204 interface PCB (transceiver unit).

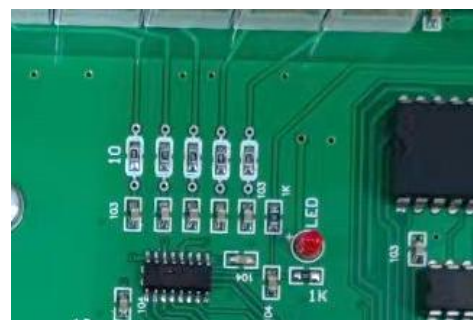
Tune at every band. The ATU starts to TUNE (make ta..ta..ta.. sound), then stops and LED of ATU will be ON, which means TUNE OK.

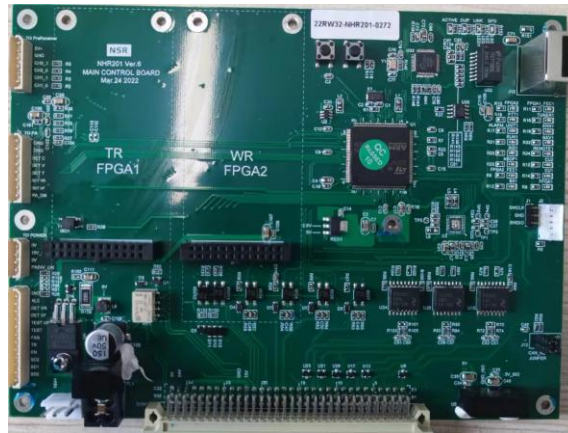
If ATU keeps TUNING always (keep making ta..ta.. sound):

- 1) Improve the ground.
- 2) Place a temporary wire antenna about 10-12 meters instead of the existing antenna, to confirm if the fault is caused by the antenna.

The ATU should work fine. But still TUNE ERR, that means the READY signal is not received by the transceiver unit, the problem may come from NHR201.

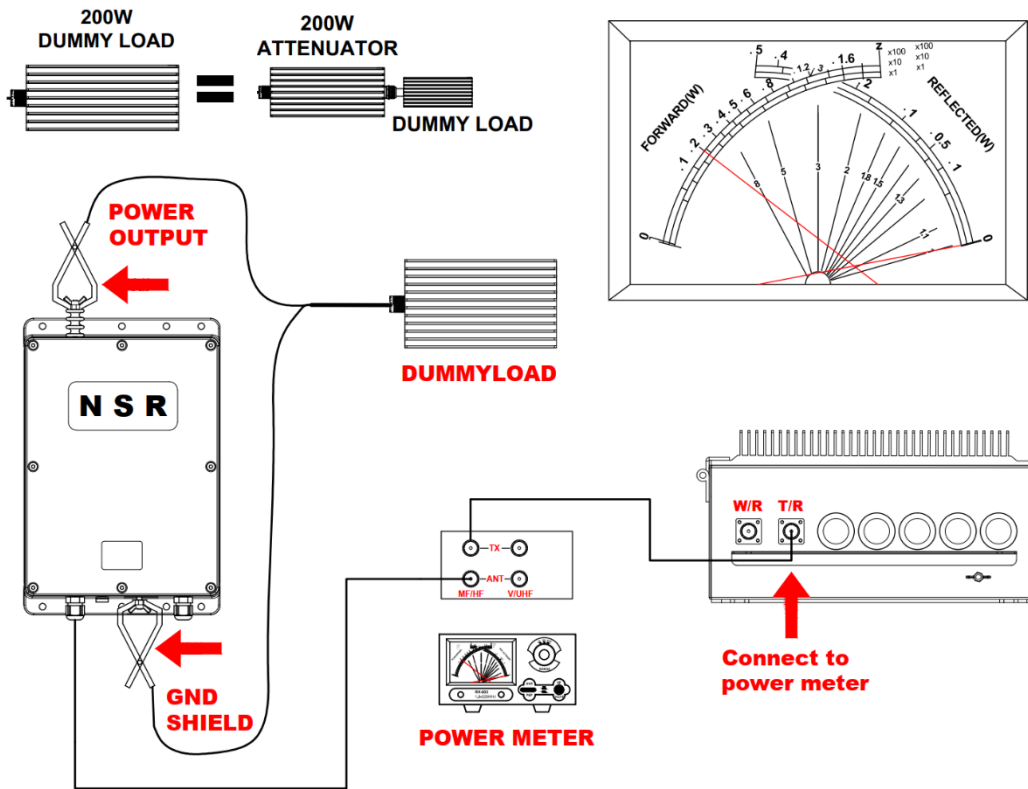
Test Connection 2: Power Meter + ATU + Dummy load

Note: The 200W dummy load can be replaced by a 200W/40dB attenuator and a 20W dummy load.

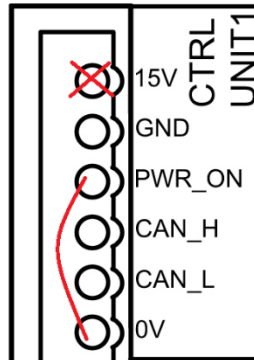
- 1) Plug out the 15V from the CTRL UNIT1 connector. Short circuit PWR_ON and 0V.

If the transceiver is powered ON normally at this step, that means the control unit is faulty. Please check as Step 4.

If the transceiver is not powered ON and no 15V between “15V” and “GND”, please check as Step 2.

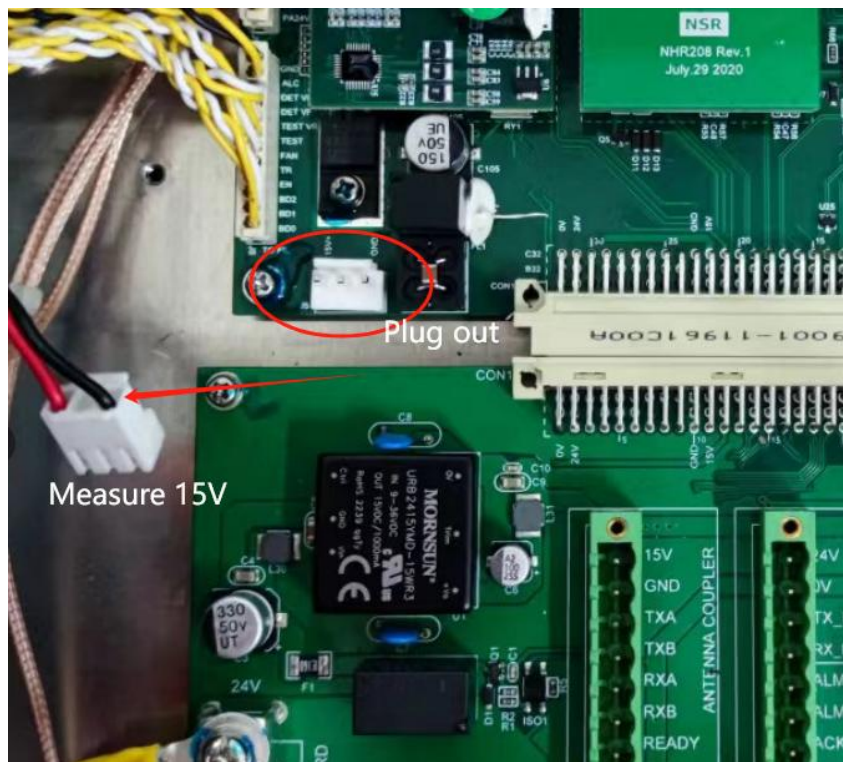
If there is no 15V, the NHR202 PCB should be faulty.

If the 15V is OK, something is short-circuited at NHR201 mainboard. Please check as Step 3.

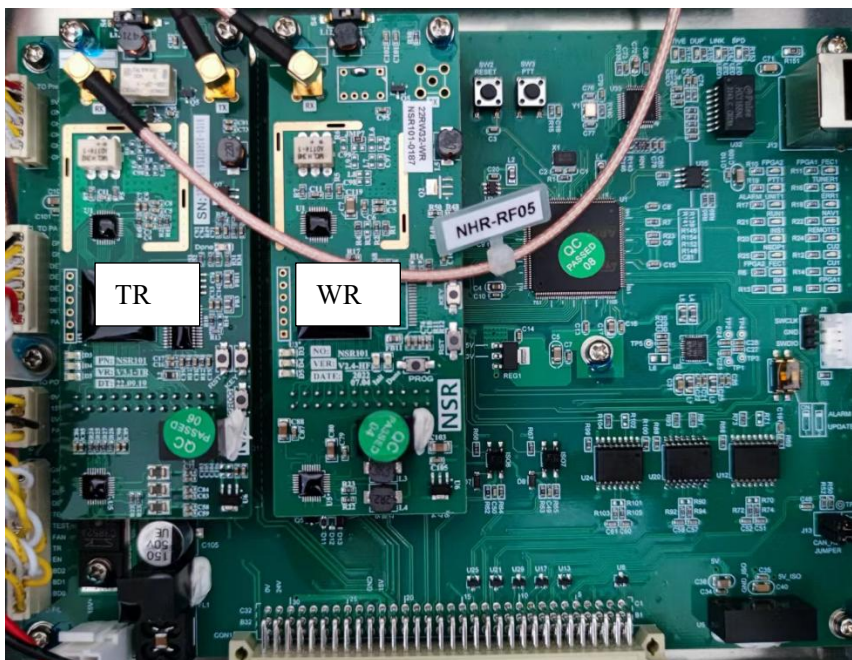
- 3) Remove the TR and WR PCB, and check the 15V at Step 1 when PWR_ON and 0V are shorted.

If 15V is OK when the TR and WR PCB are removed, the TR or WR PCB may have something short-circuited.

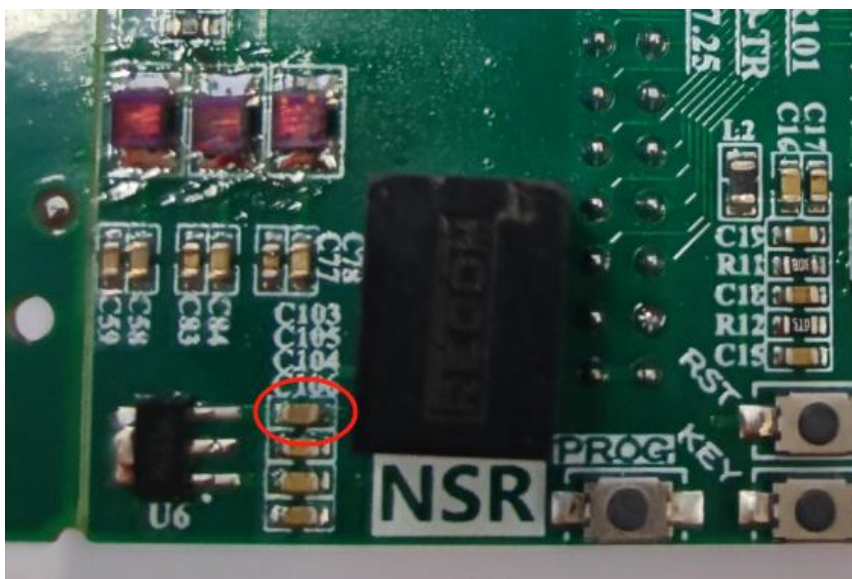
Check C103 (10uf 25V 0603) at NSR101 PCB. If C103 short-circuit, it can be removed.

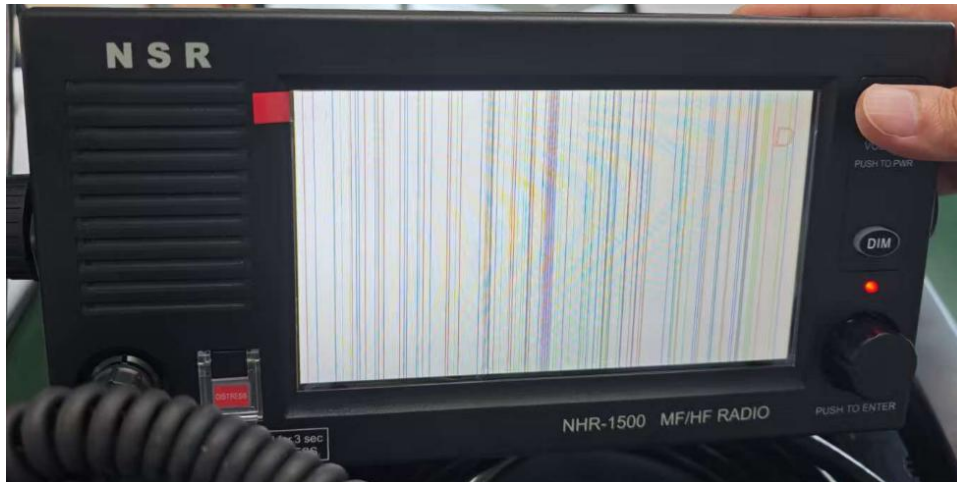
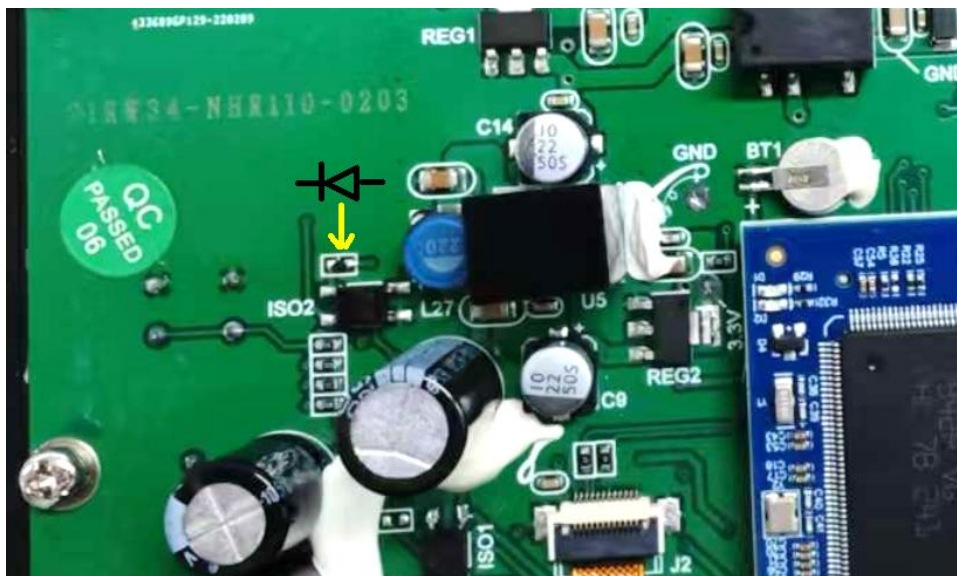
If keep pressing the volume key, the screen is ON, and the screen is OFF after releasing the volume key, the ON_OFF control circuit may be faulty. Change the component marked to 0 ohm resistor or SZMMSZ4679T1G zener diode.

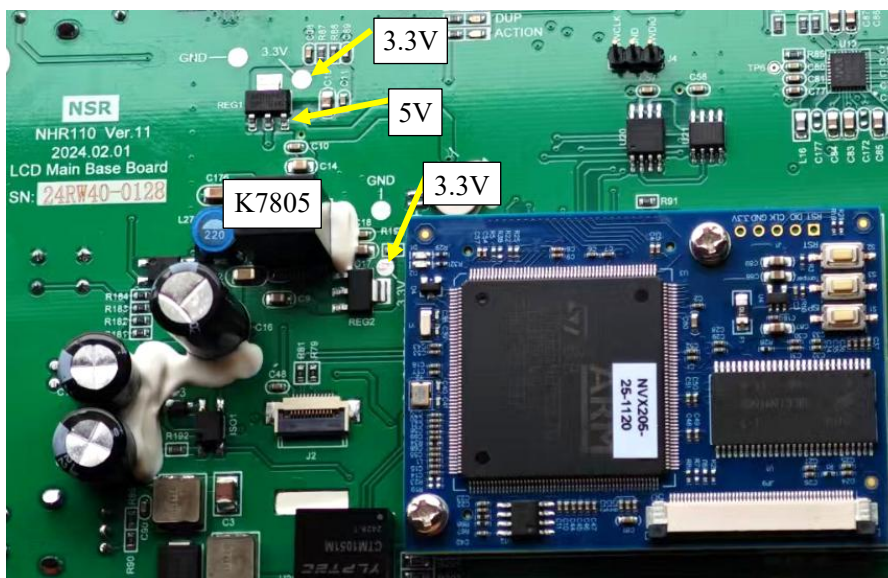
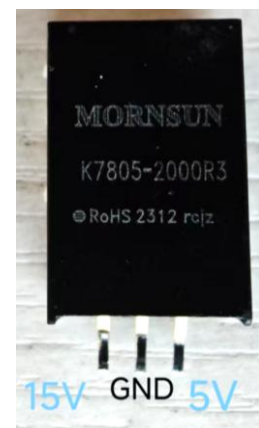
If keep pressing the volume key, the screen is always OFF. Please check the voltage of NHR110 PCB when the volume key is kept pressing.

If 5V is not OK, please replace the DC-DC converter K7805.

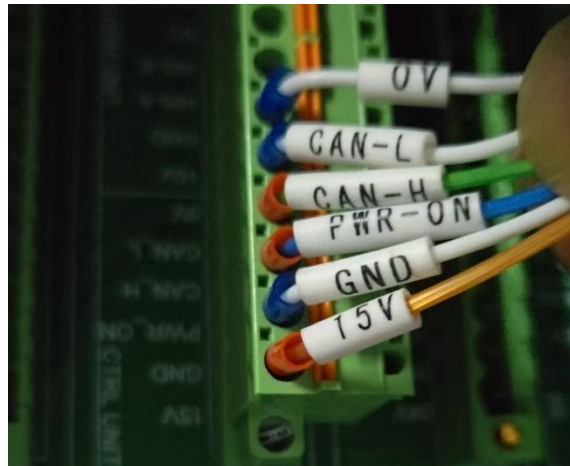
- 1) If the control unit or transceiver unit has been upgraded or replaced by a new one, the software version should be matched (See Section 1.2 Software Compatibility), or use the latest version for both the control unit and transceiver.
- 2) Check the cable connection between the control unit and transceiver. The cable should be originally supplied from NSR. If the required length exceeds the standard configuration, please contact NSR.

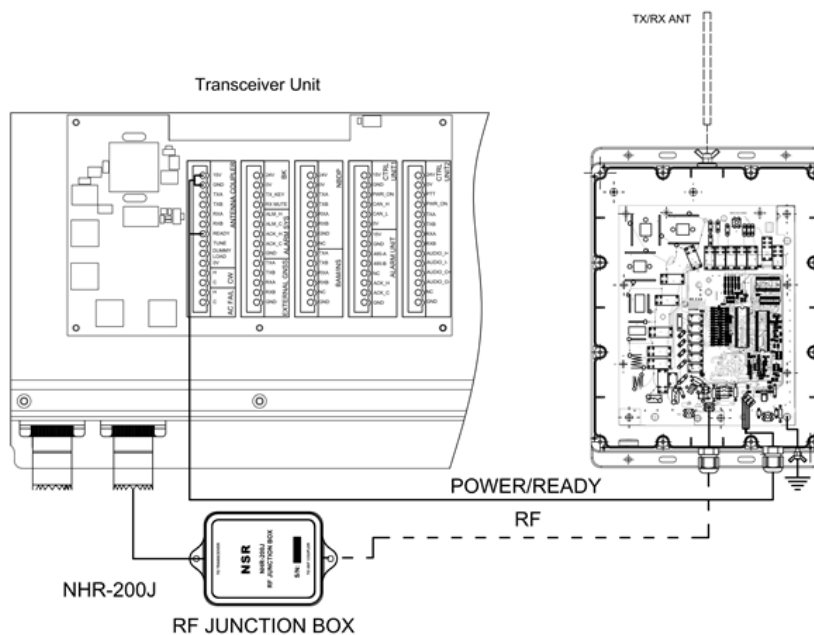
Install NHR-200J RF junction box between the transceiver unit and ATU. It is used to suppress current variations for improving antenna matching.

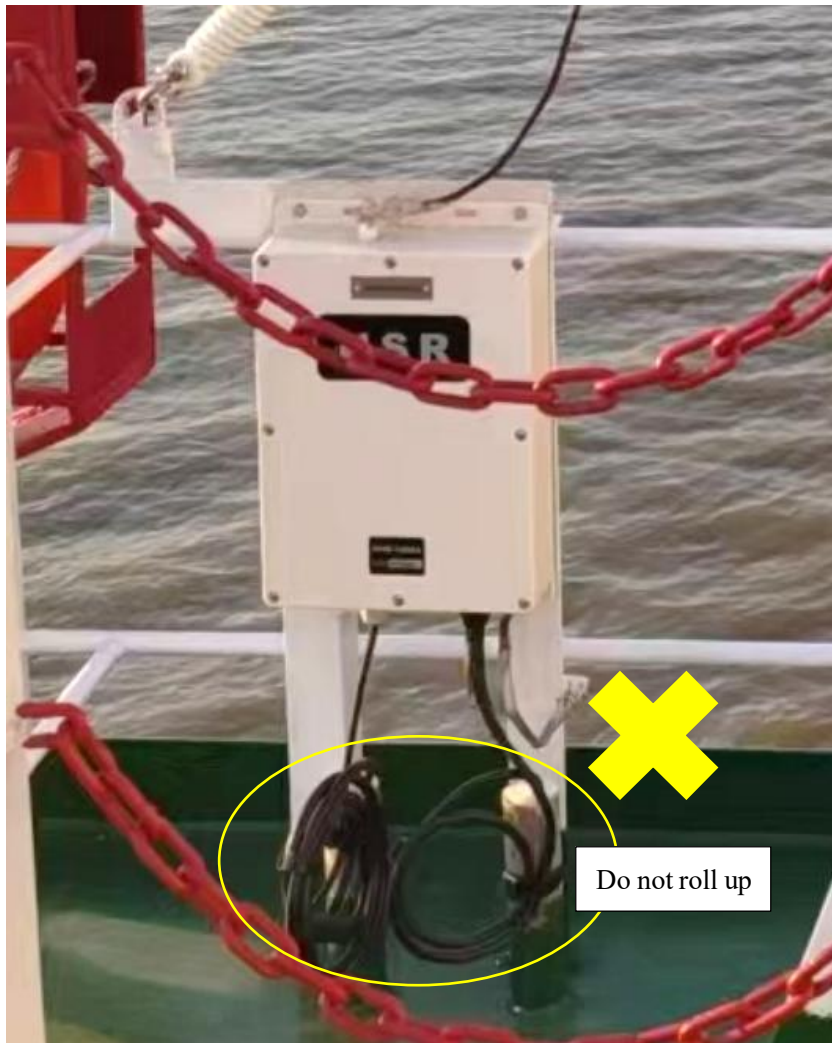
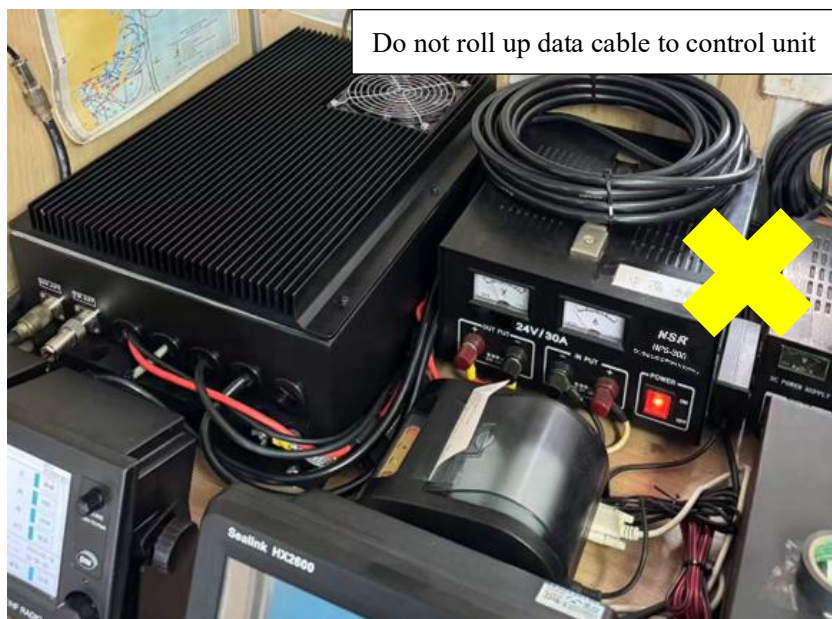
If there are any extra cables, please do not roll them up. They need to be cut or straightened.

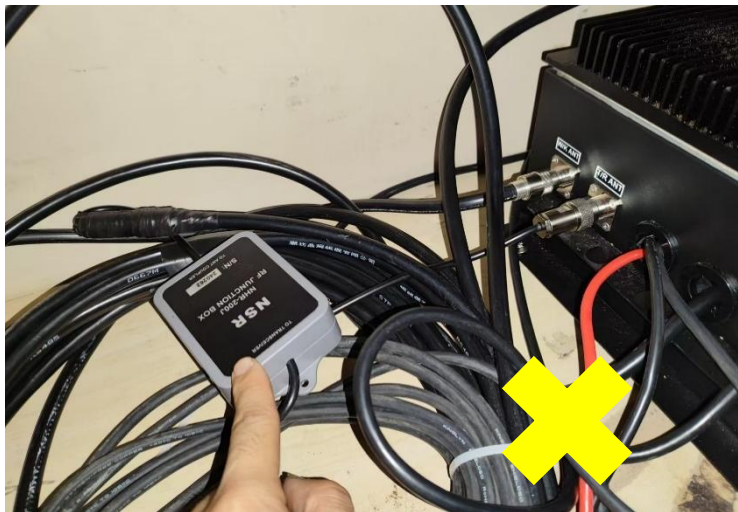
And please do not bundle data cables and RF cables together.

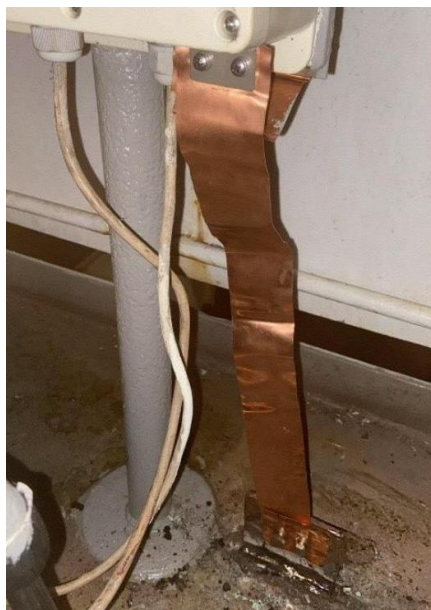
1) ATU

The grounding copper strip needs to be welded to the hull to ensure good grounding.

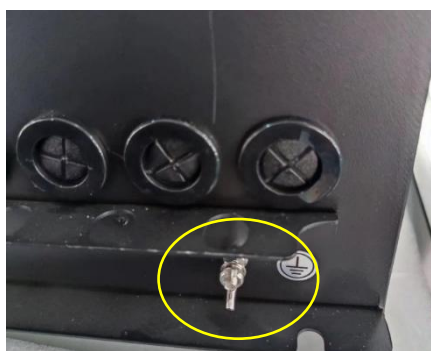
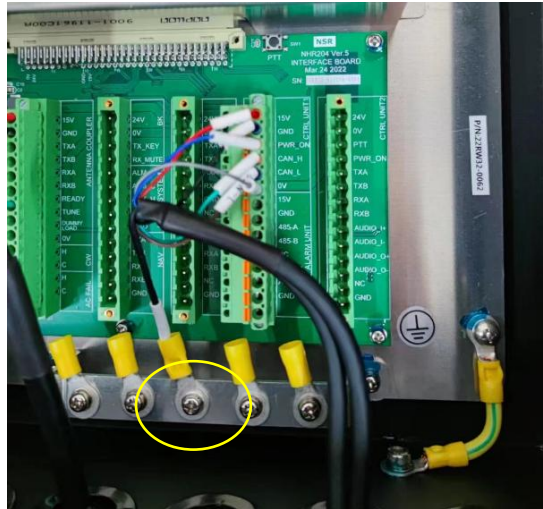
2) Transceiver unit

Confirm the shield of the cable to the control unit is well grounded.

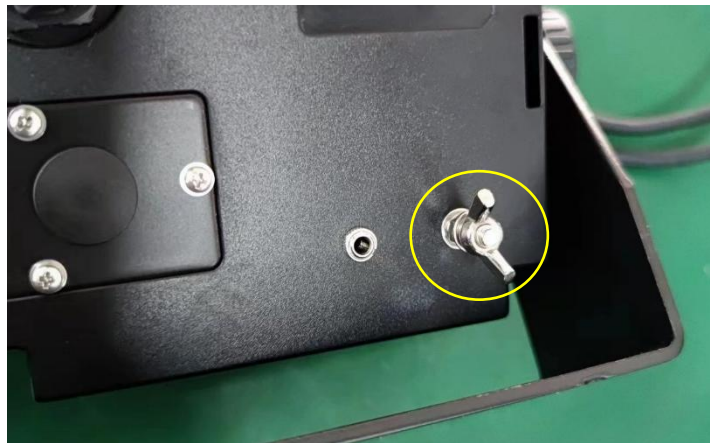
3) Control unit

Confirm the control unit is well grounded.

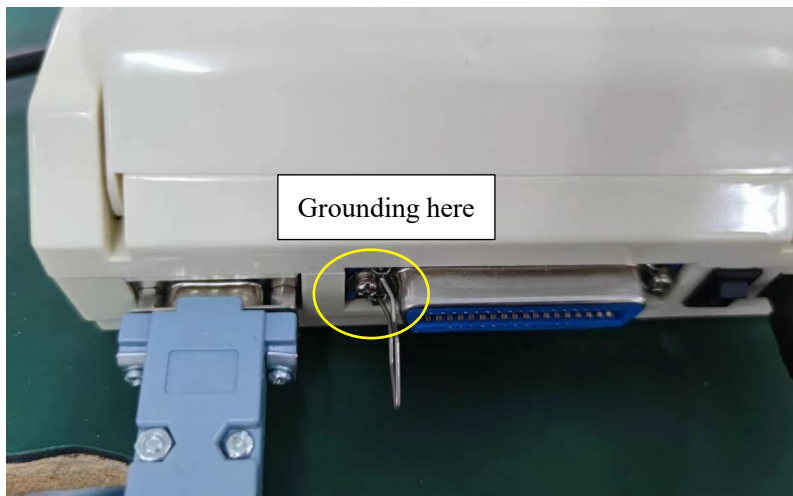
4) Printer

Confirm the printer (if any) is well grounded.

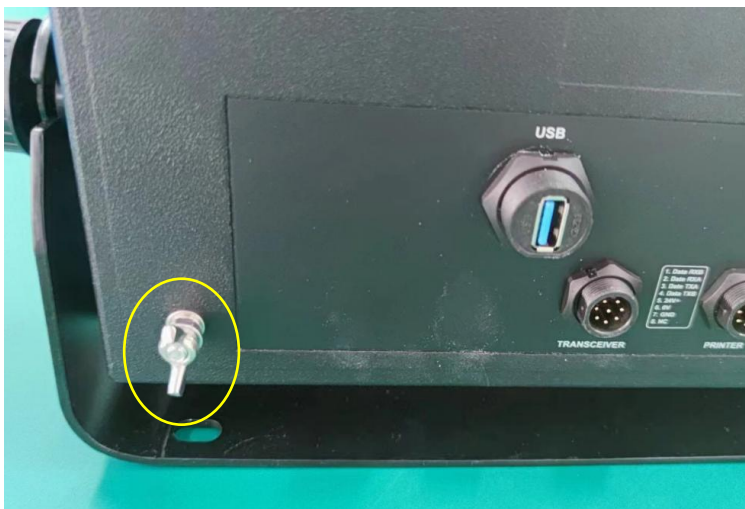
5) NBDP terminal

Confirm the NBDP terminal (if any) is well grounded.
